# Naval Research Laboratory

NRL/PU/6110- -99-388

## Advanced Nontoxic Fouling Release Coatings

Environmental Security  
Technology Certification  
Program

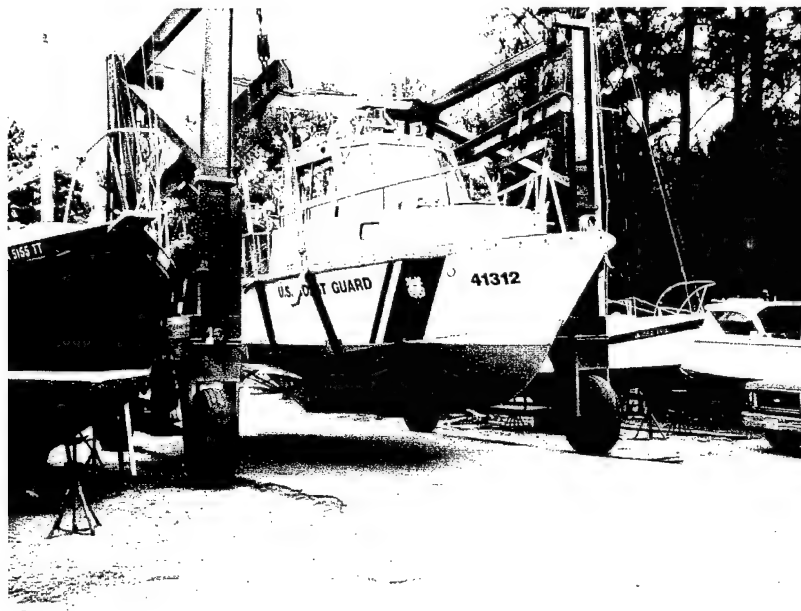
**Figure 5-1.** The duplex coating system as applied to UTB 41312.

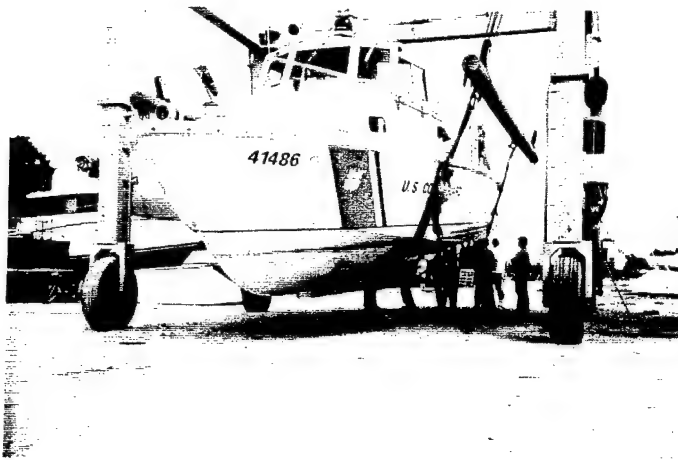
USCG UTB PENNSACOLA, FL  
(18 JULY 96)

**Figure 5-2.** Duplex system applied to UTB 41486 after one year of service.

UTB 41486 proved to be the first instance of delamination on a boat platform that required extensive repair. The duplex coating system had been rolled on prior to the development of spraying expertise. A dive inspection in the summer of 1996 reported that the coating was "peeling off" and the hull was severely fouled. When the boat was pulled from the water for repairs in September 1996, the damage was found to be much less extensive than reported; only 10 ft<sup>2</sup> of the original 400 ft<sup>2</sup> had delaminated, and no hard fouling was observed (except on exposed epoxy paint).

A photograph of the duplex system on the UTB 41486 after one year of service is shown in Figure 5-2. The damage was repaired with RTV11® catalyzed with SCM501C®, which contains a high percentage of adhesion promoter to adhere to many types of surfaces. Unfortunately, the repair to UTB 41486 was unsuccessful, mostly likely due to poor surface preparation of the repaired area, and the Duplex system was removed and replaced with a conventional marine paint. The EXSIL2200® coating system on UTB 41345 was also removed at the same time and replaced with a competitor's easy release coating.

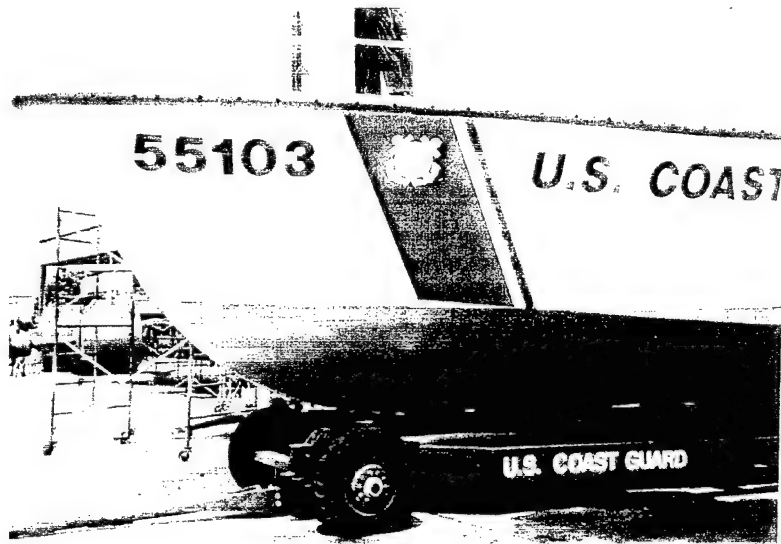
**Figure 5-3.** Duplex coating as applied to USCG 55103 (Parramore).

The duplex coating on the USCG 55103 (Parramore) is shown in Figure 5-3. An inspection after four months of service showed very good performance; a gradient of increasing fouling toward the keel indicated self-cleaning ability, and minor sand abrasion damage at the rudders and keel showed the coating's durability and good adhesion. The coating on the Parramore was removed without warning in 1997. Personnel at Yacht Maintenance in Cambridge, MD, where the boat was pulled for recoating, reported that the coating was in excellent condition when the boat was pulled and that the little macrofouling that existed was easily cleaned from the hull.

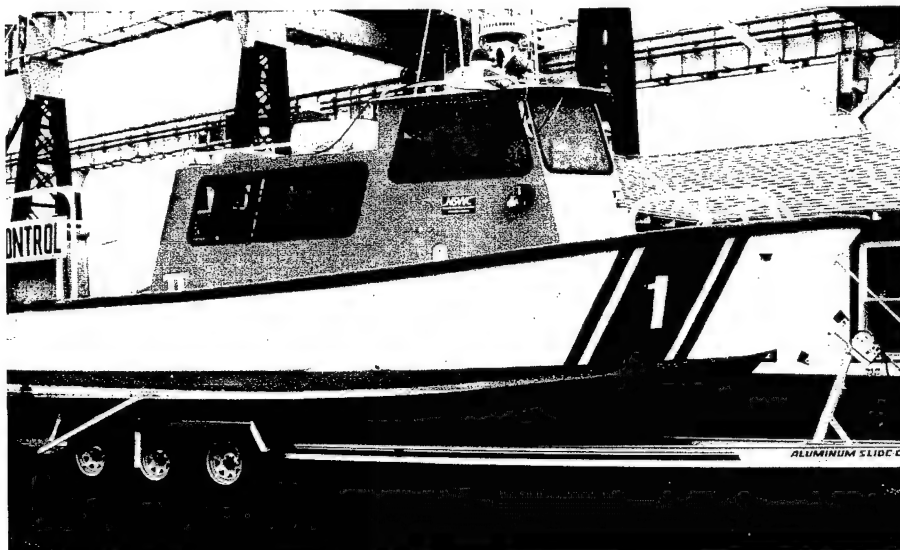
**Figure 5-4.** U.S. Navy RCB-1 coated with the duplex fouling release coating system using the EXSIL2200® gray topcoat; this boat was coated in September 1996 in Vallerlee, Virginia.

test the duplex coating system against the fouling indigenous to tropical Pacific waters. Minor repairs to the U.S. Navy range control boats took place in May 1998; abrasion damage along the waterline and delamination at the block shift patches were repaired with the GE SEA210A®/GE SCM501C® repair package with an EXSIL2200® topcoat. There have been no further complaints of delamination or repairs needed. The users of the RCB's are happy with the fouling release performance and durability of the duplex coating system. A photograph of the EXSIL2200® coating's appearance on RCB-1 is shown in Figure 5-4.

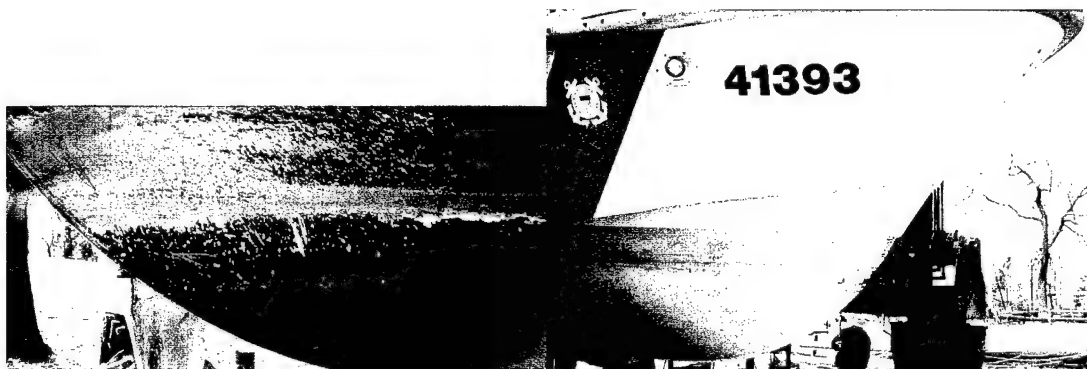
**Figure 5-11.** Comparison of ice damage to a competitor's fouling release coating (left) and the NRL-GE duplex fouling release coating system (right) on two 41' USCG UTB's.

One advantage of the NRL-GE duplex coating system is its durability and toughness relative to that of existing commercial silicone fouling release coatings. Ice abrasion damage on the U.S. Coast Guard UTB's 41312 and 41393 occurred to a much lesser extent than abrasion damage to a competitor's coating on a nearby 41' UTB. A comparison of the damage to these UTB's is shown in Figure 5-11.

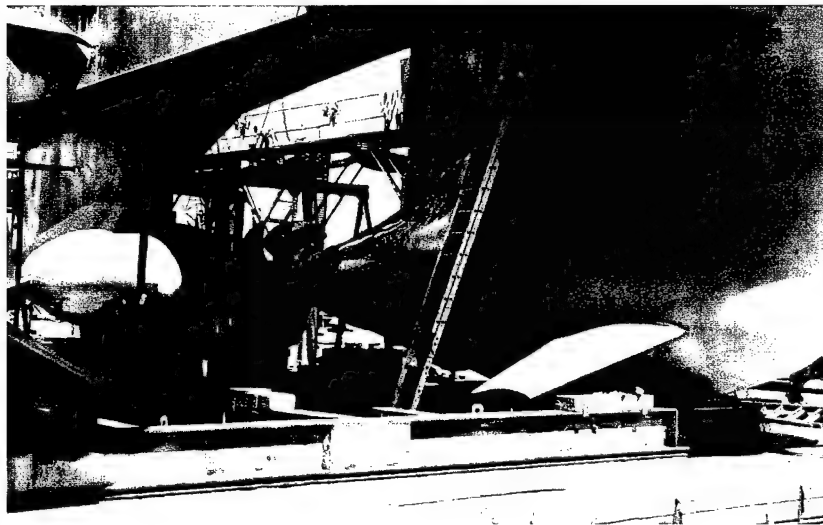
**Figure 5-12.** Duplex coating (EXSIL 2200® topcoat) was applied in November 1996 to the port hull (ponton-like supports called pods) of the ONR-Lockheed prototype SLICE.

Figure 5-12 shows the NRL-GE duplex coating system (Exsil2200® topcoat) applied to the ONR/Lockheed prototype (SLICE). Dive inspections of the SLICE compared the performance of the NRL-GE duplex coating on the port pontoons with the competitor's coating (Figure 5-13), but because the SLICE was docked with the starboard side to the dock and macrofouling was reported by SLICE personnel to be less against the dock, the fouling pressure on the starboard (competitor's) side of the boat might have been less than that on the port (duplex coating system) side.
